Manhole Inspection Summary

Manhole # S27G__025MH

Insp Date: **5/20/08 11:15 AM**

Location Address: **919 N Poppleton St** Cross Street: **W Fayette**

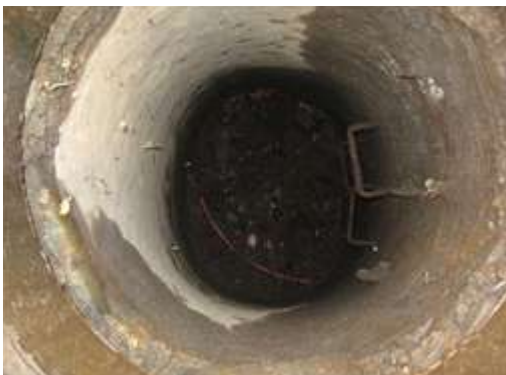
Additional Top View

Frame Offset: **0** (in.) Condition: ☐ Sound ☐ Cracked ☒ **Leaks**

infiltration frame -chimney connect

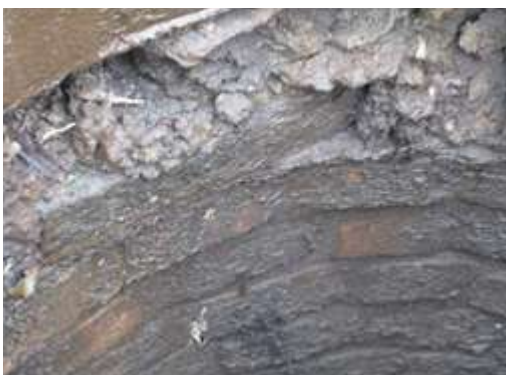
Defect 4

loose brick/ missing mortar / chimney infiltration

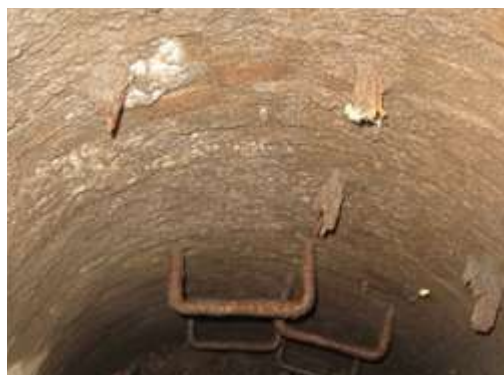
Defect 3

Condition: ☐ Sound ☐ Cracked ☐ Root Intrusion ☐ Loose Brick ☒ **Deteriorated**

Infiltration: ☐ None ☐ Joint ☐ Cracks ☐ Mortar ☐ Roots ☒ **Wall**

corbel cond deteriorated, corbel flow wall

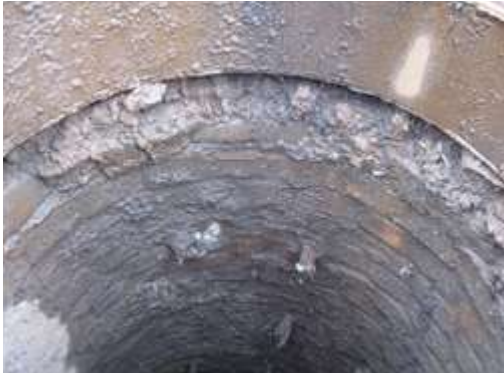
Defect 2

Condition: ☐ Sound ☐ Cracked ☐ Root Intrusion ☒ **Loose Brick** ☒ **Deteriorated**

Infiltration: ☐ None ☐ Joint ☐ Cracks ☐ Mortar ☐ Roots ☒ **Wall**

chimney cond loose bricks, chimney cond deteriorated, chimney flow wall, missing mortar

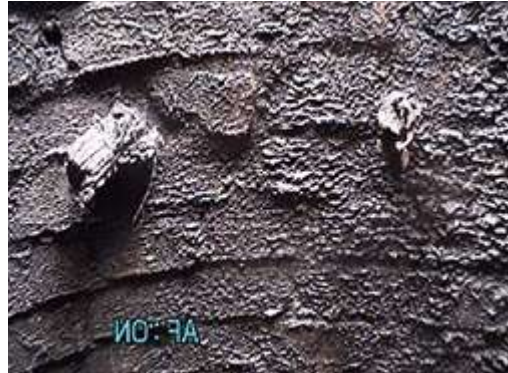
Defect 1

Steps Count: **6** Missing: **2** ☒ **Corroded**

missing step
